# TEST REPORT

No. : SHAM20191105124  
Date : Jan.2,2020  
Page : 1 of 4

Sample Name : CCGrass  
Sample Number : SHAM20191105124  
Test Required : Ignitability of building products subjected to direct impingement  
of flame – part 2: single-flame source  
Date of Receipt : Nov.27,2019  
Test Period : Nov.27,2019~Dec.5,2019  
Test result(s) : For further details, please refer to the following page(s)

#### 1.EN ISO 11925-2:2010/AC:2011 Reaction to fire tests –ignitability of building products

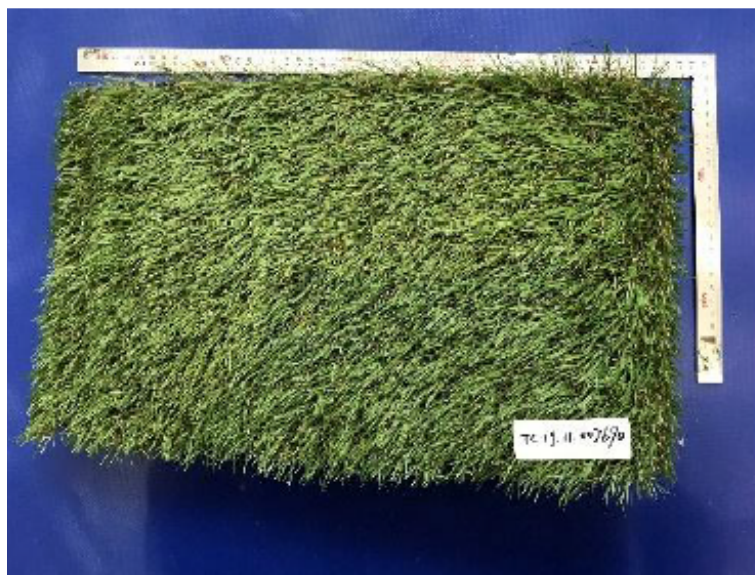
### Sample photo:

Specimen size	1050mmx230mm
Thickness	About 24.3 mm
